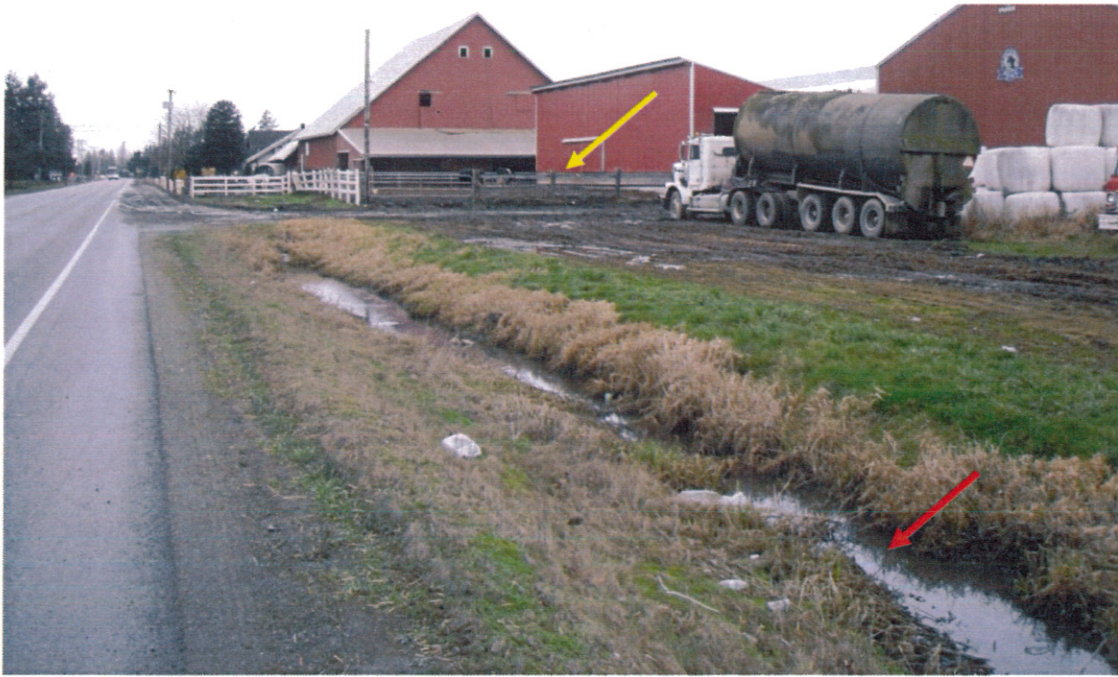
Photograph #1: View of the southern end of the facility and ditch from E. Badger Road. The yellow arrow points to the dry cow confinement area. The red arrow points to the location of sample # 13064100. This photograph was taken by Michael Isensee, Washington Department of Agriculture on February 12, 2013.

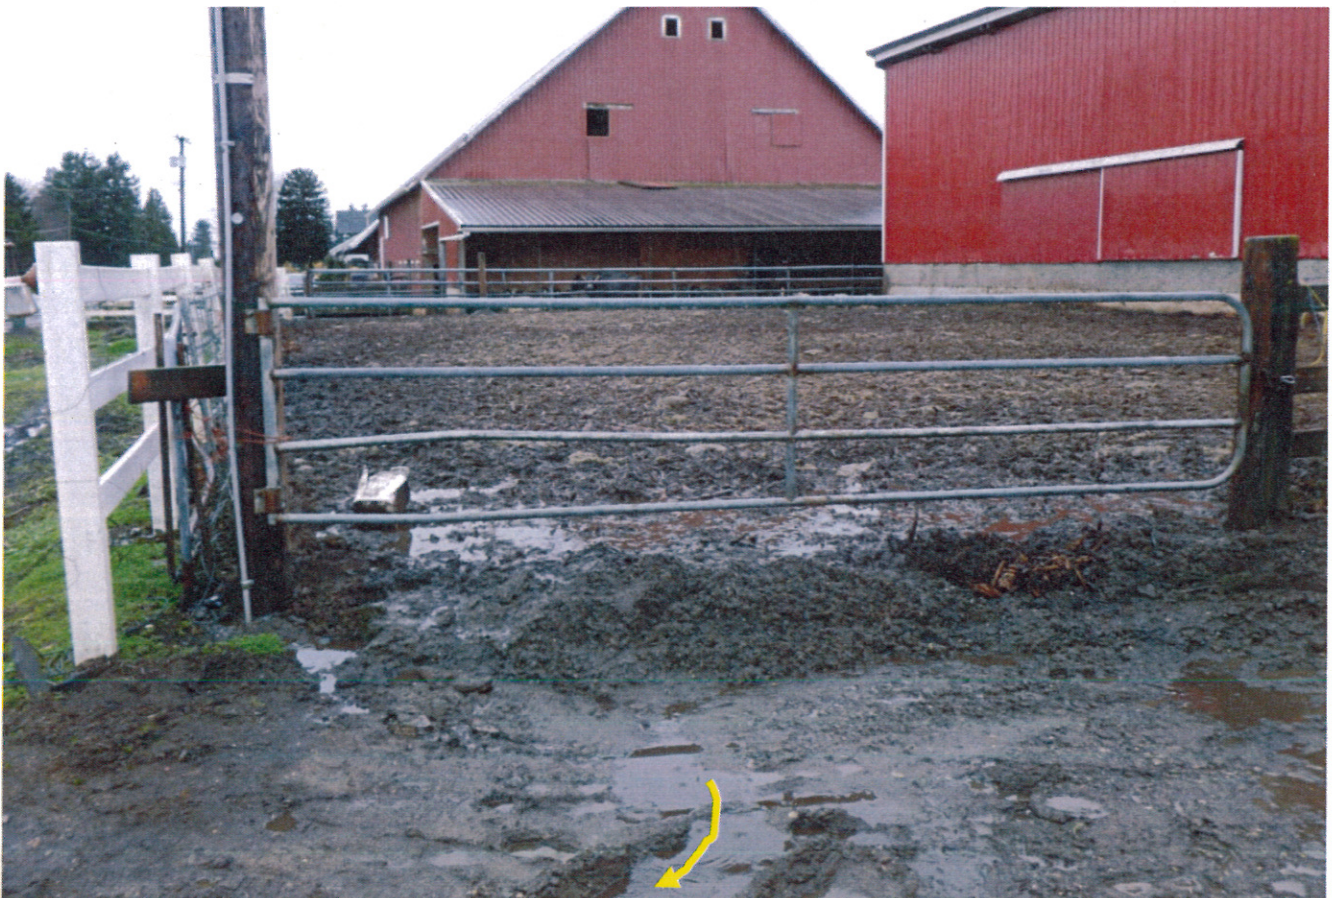
Photograph #2(P1010090-taken on 2/21/13): Looking west, this is a closer view of the dry cow confinement area. On February 21, 2013 the EPA inspectors collected a water sample of flow coming from the direction of the eastern perimeter of the dry cow confinement area. The yellow arrow indicates the direction of flow at this time. In general, the slope along the eastern perimeter of the dry cow confinement area was toward the road and trench.

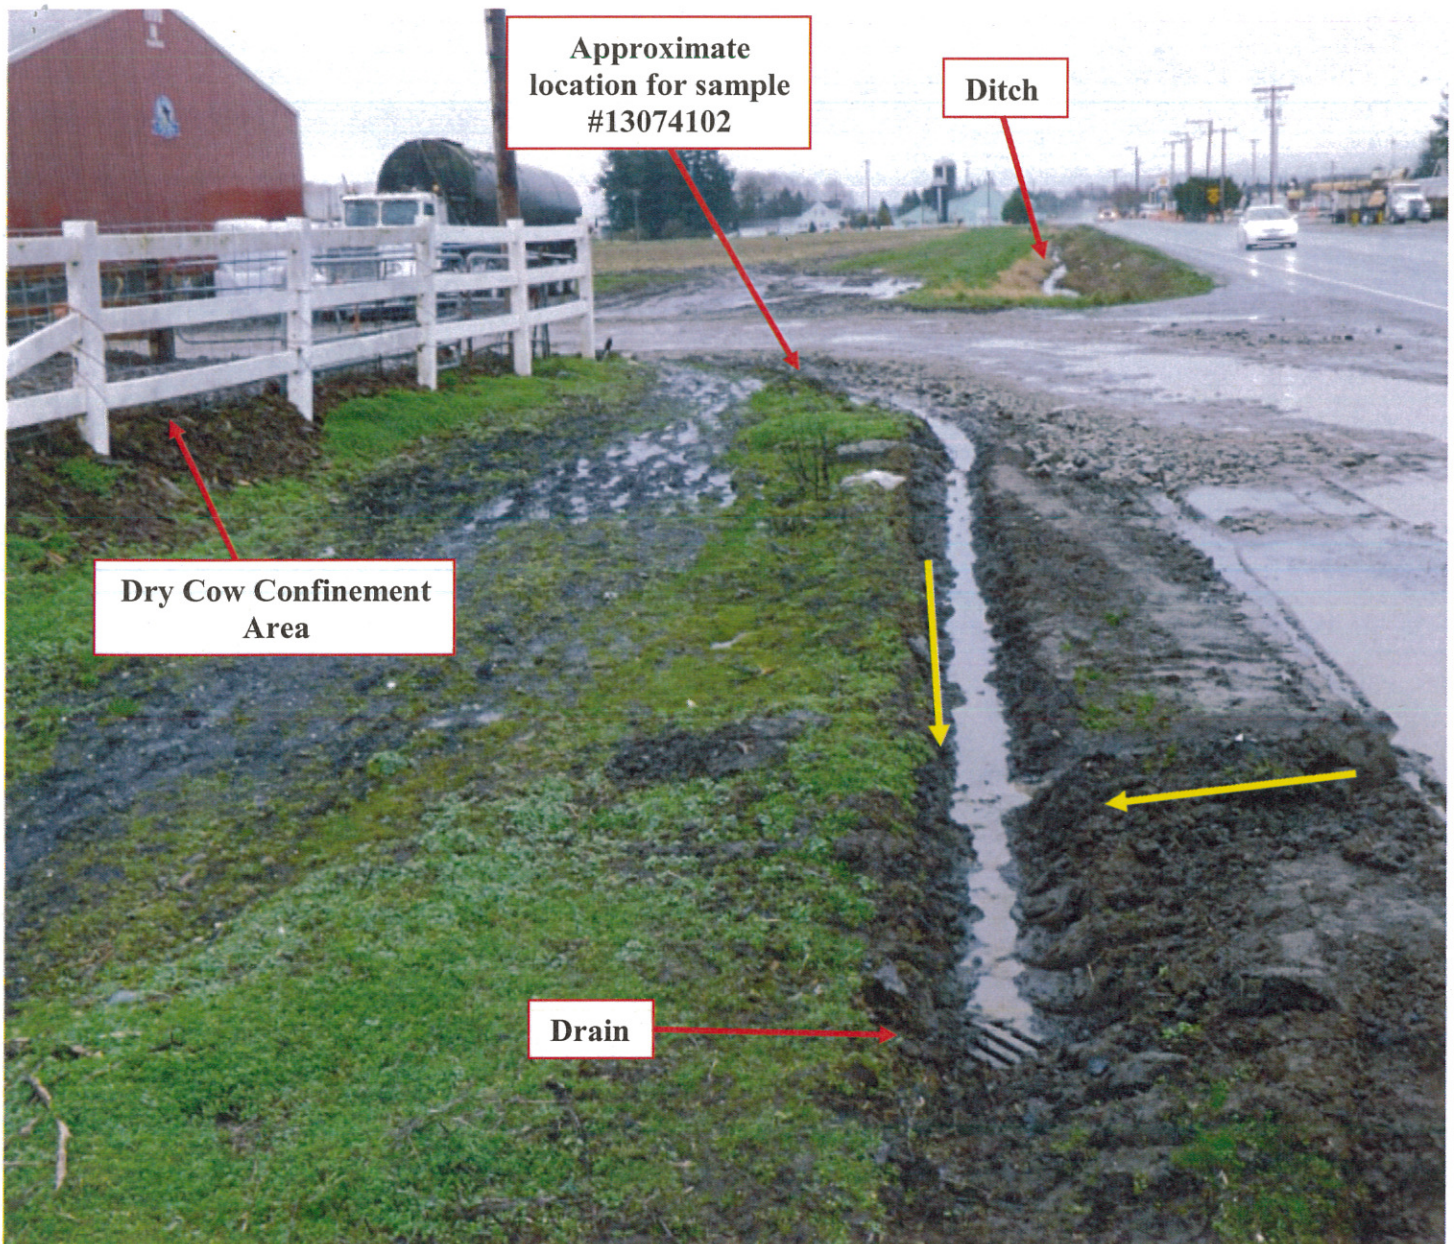
Photograph #3(P1010094-taken on 2/21/13): Looking east, this is a view of the trench located adjacent to the dry cow confinement area and the drain. Water flowing from the direction of the eastern perimeter of the dry cow confinement area was entering this trench and flowed into the drain seen here on February 21, 2013. According to Mr. Bajema, this drain routes water to the ditch, seen in the background of this photograph. The yellow arrows indicate the direction of flow in the trench.

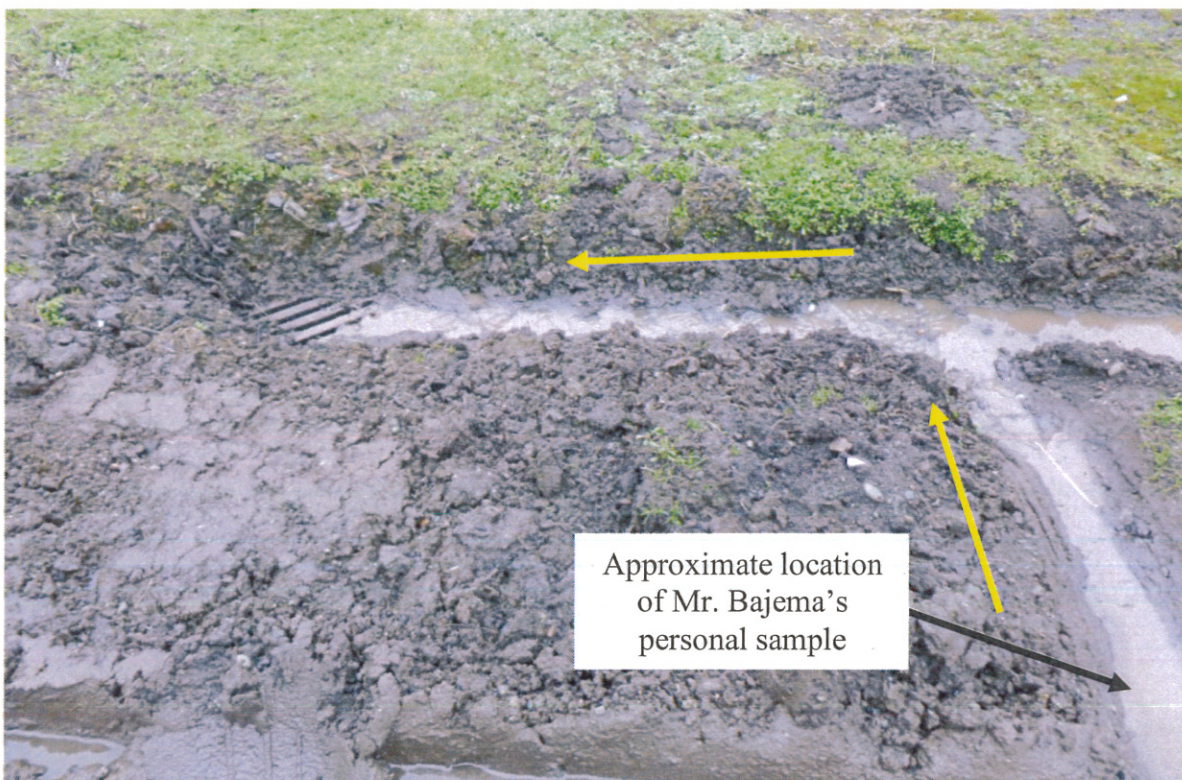
Photograph #4(P1010094-taken on 2/21/13): Another view of the drain seen in the previous picture. Runoff from the direction of the road was also entering this drain, via the channel seen in the bottom right corner of the image. Mr. Bajema collected his personal sample of the water flowing in this channel. The yellow arrows indicate the direction of flow at the time of inspection.

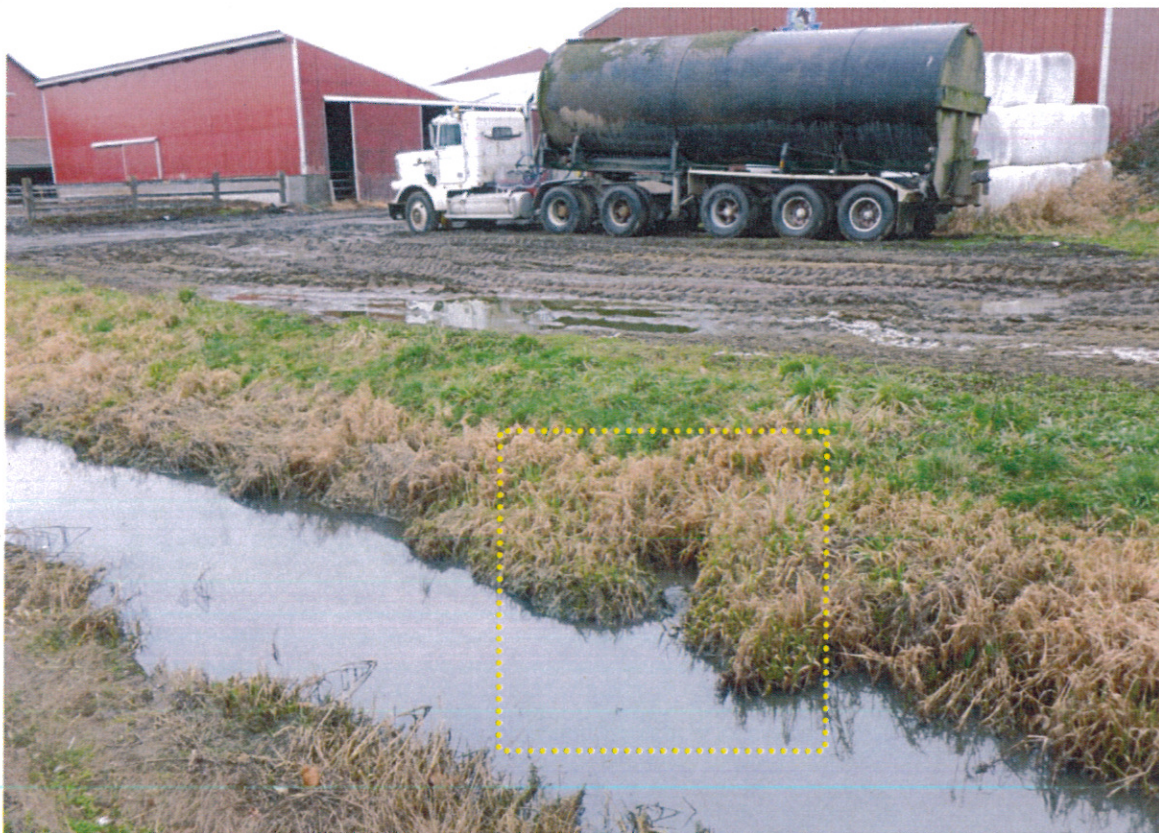
Photograph #5(P1010066-taken on 2/12/13): Looking northwest, this view is of the ditch and the flow of water entering the side of the ditch, highlighted by the yellow box. Mr. Bajema stated that this flow of water is from the northern barn roof runoff. This flow of water is the location for sample #13064101 and # 13074100.

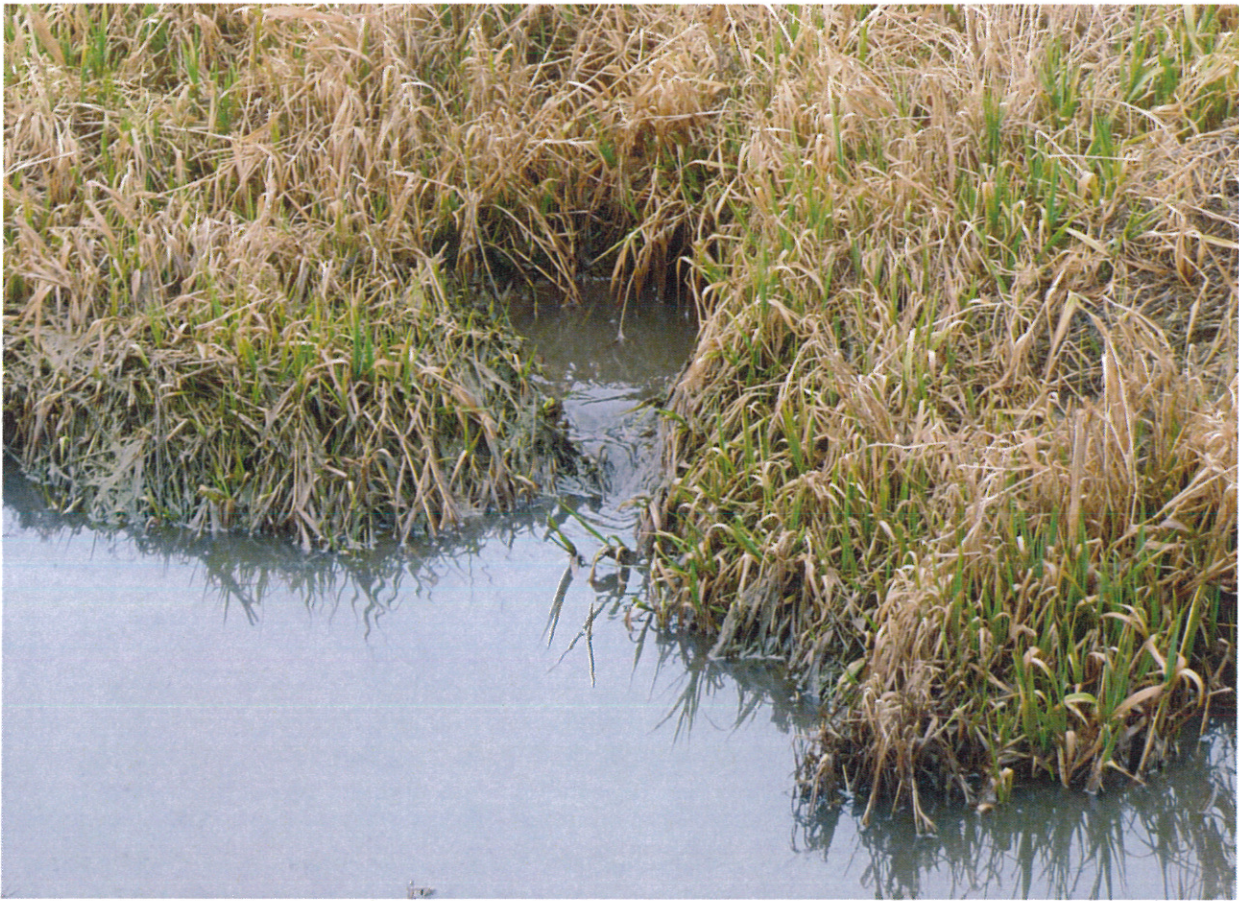
Photograph #6(P1010065-taken on 2/12/13): This is a close up of the water flow seen in the previous picture.

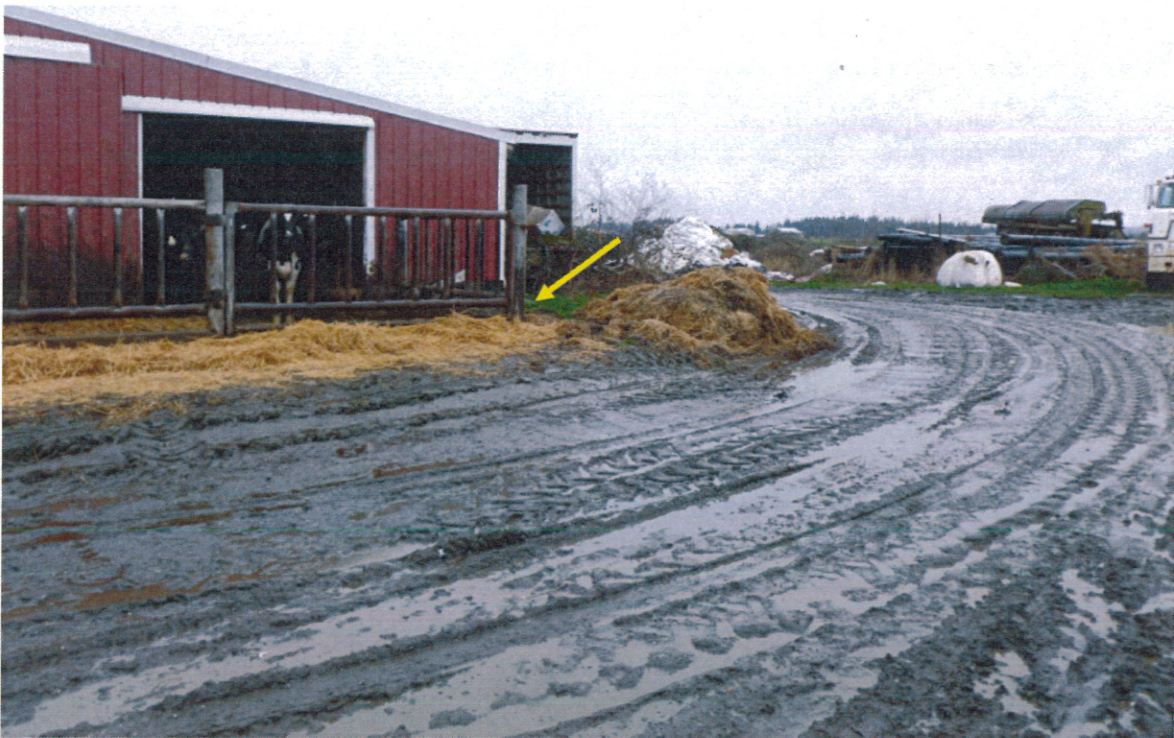
Photograph #7(P1010086-taken on 2/21/13): Looking at the northeast corner of facility, specifically the northern barn. The yellow arrow points to the location of the roof runoff drain.

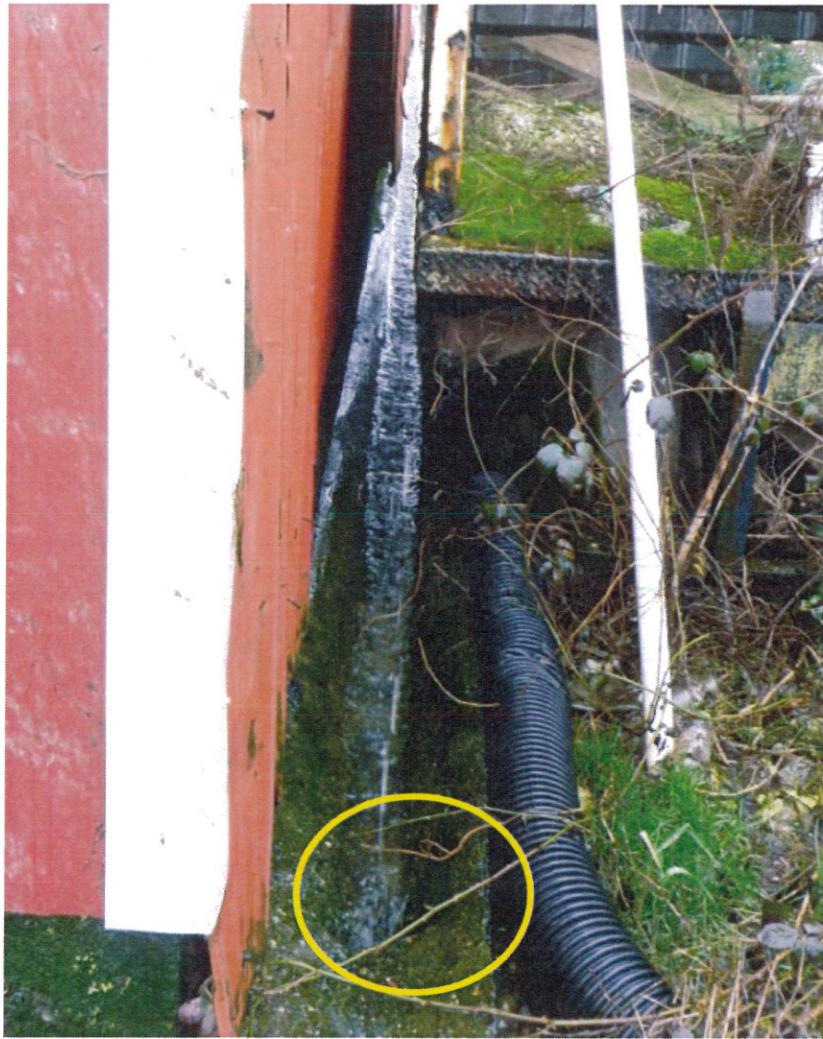
Photograph #8(P1010081-taken on 2/21/13): View of the cement trough that captures and routes roof runoff into the drain (indicated by the yellow circle) and ultimately into the ditch.

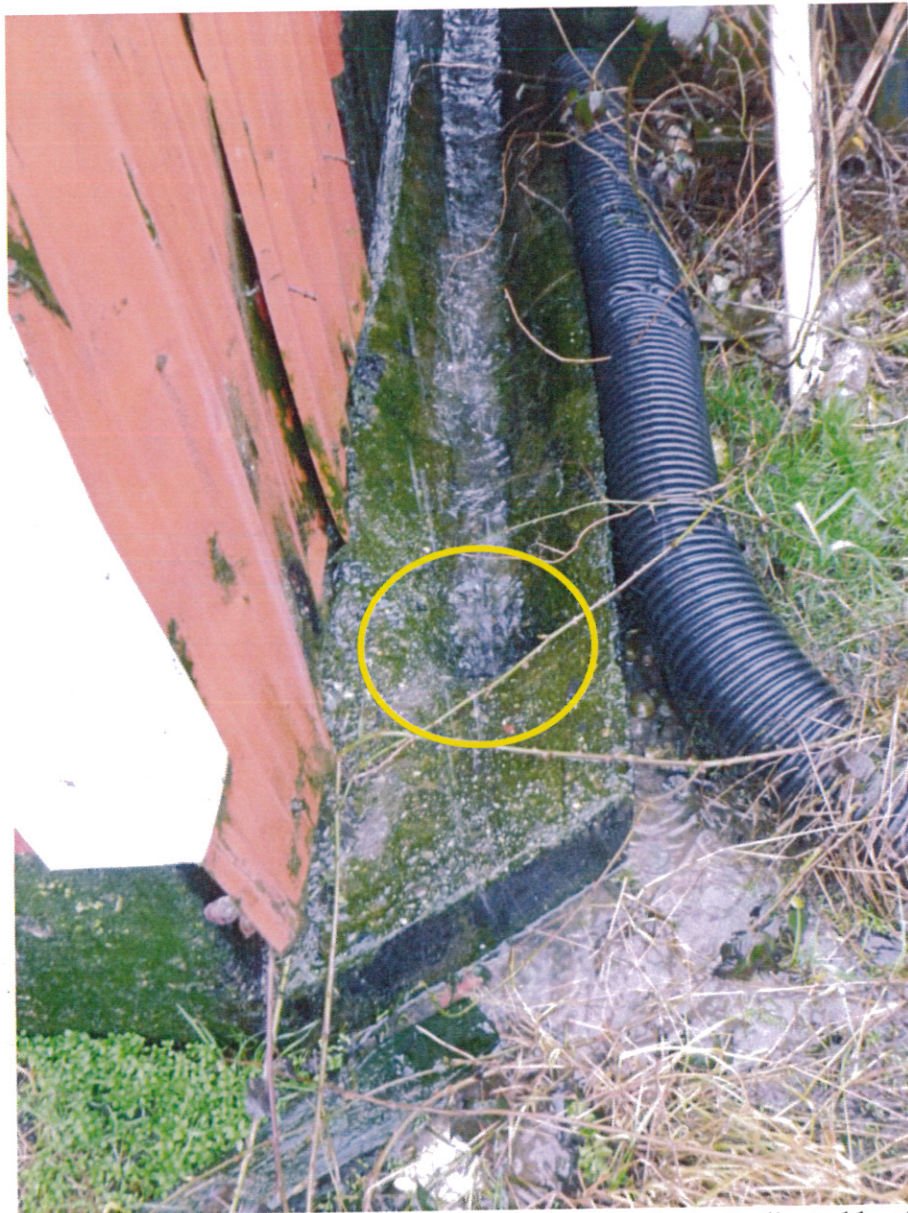
Photograph #9(P1010082-taken on 2/21/13): Close up view of the drain (indicated by the yellow circle) that routes roof runoff into the ditch. Note the cement trough and drain are elevated above ground level.

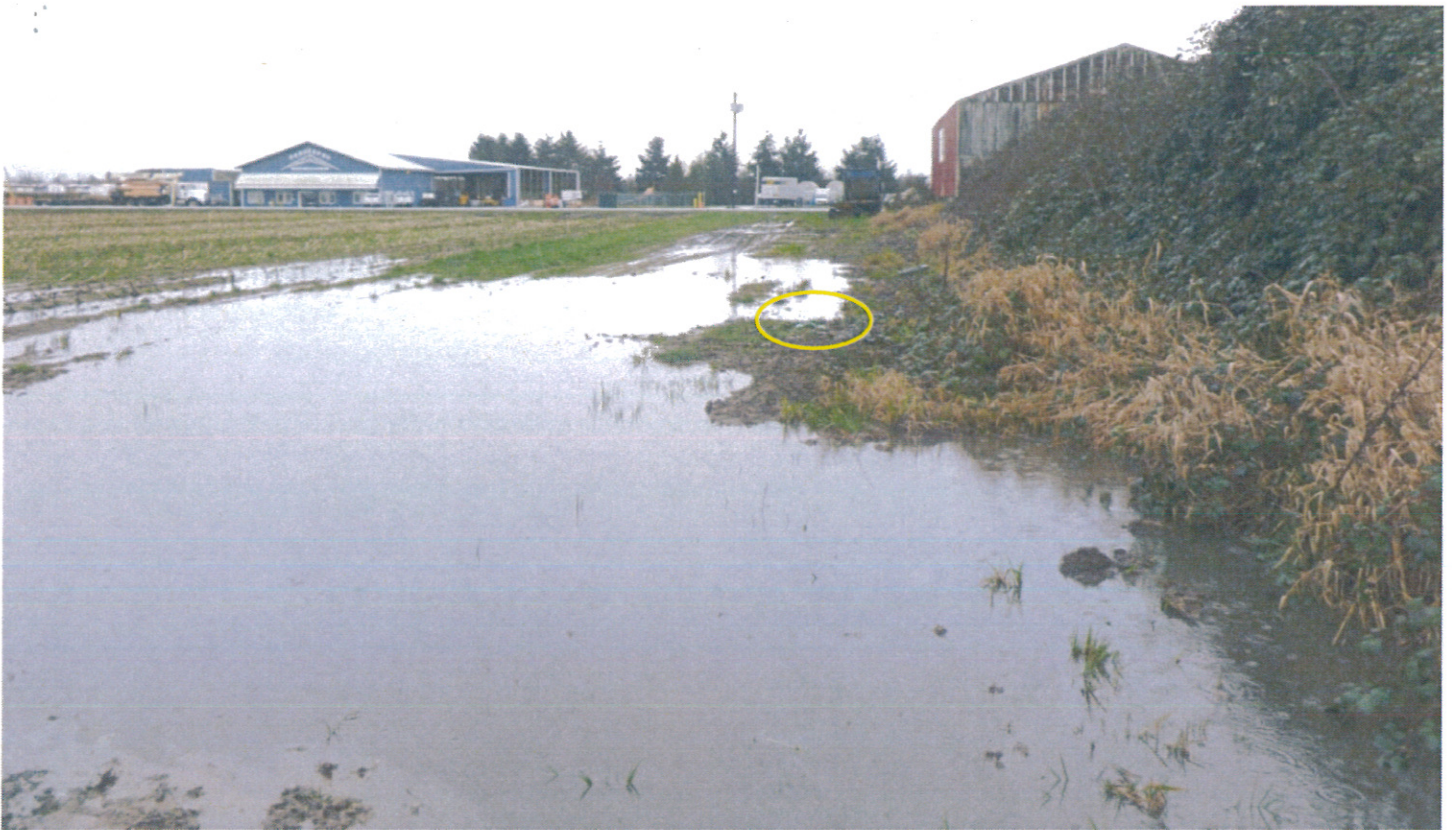
Photograph #10(P1010095-taken on 2/21/13): Looking south, this is a view of the field where, according to Mr. Bajema the pipe routing roof runoff to the ditch was broken. On February 21, 2013 there were pieces of broken pipe in this vicinity. The yellow circle highlights some of those pieces. Mr. Bajema stated that manure that had been applied to this field may have mixed with water and drained into the ditch. The ditch runs parallel to the road seen in the background of the photo.

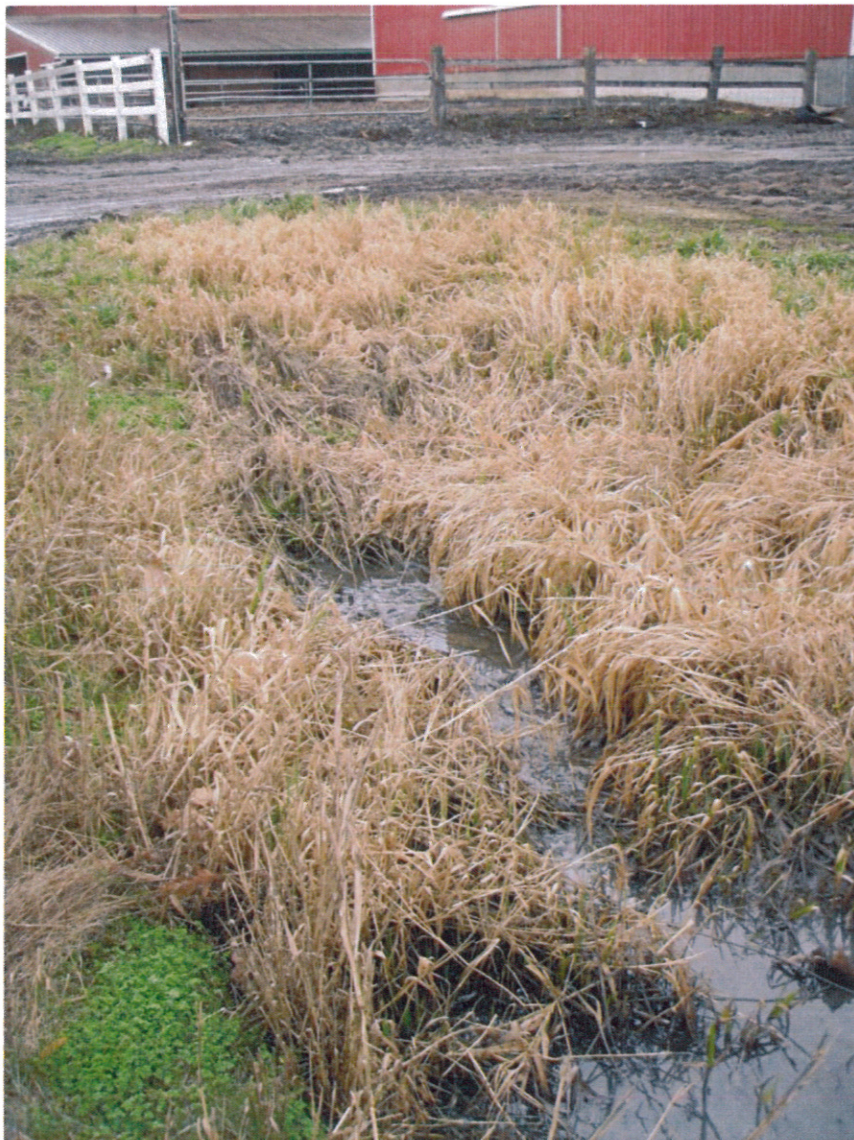
Photograph #11: View of water flowing at the beginning of the ditch. This is the sample location for #13064102 and #13074101. This photograph was taken by Michael Isensee, Washington Department of Agriculture on February 12, 2013.

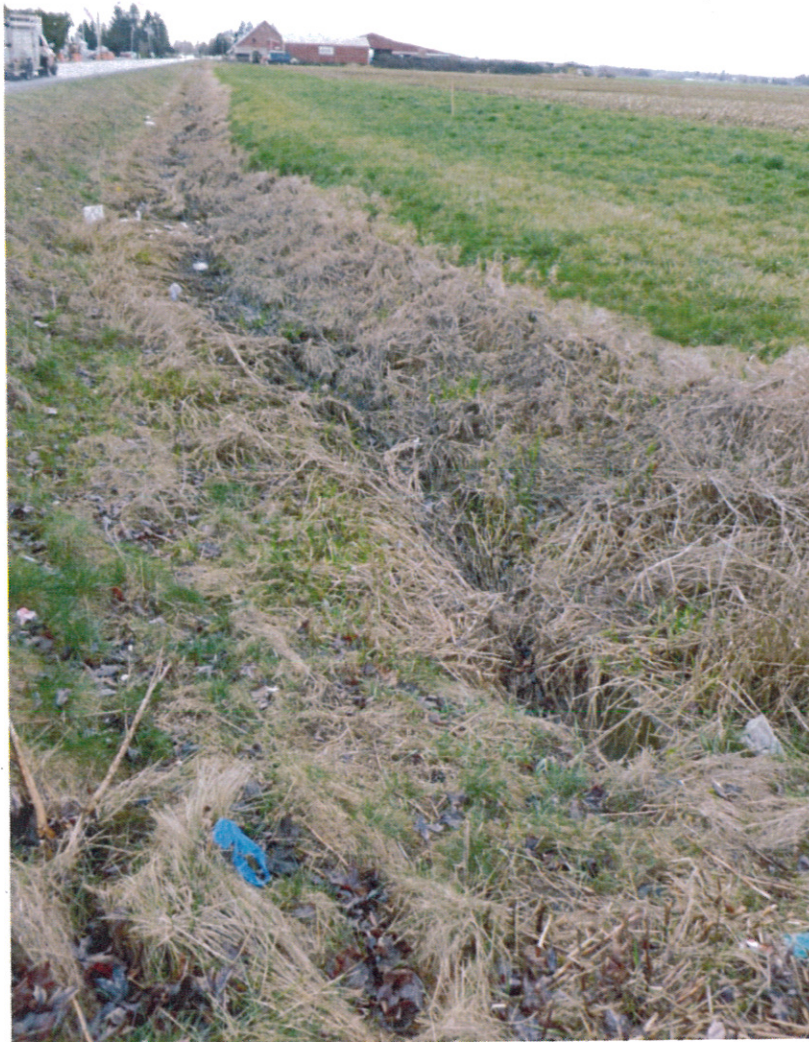
Photograph #12(P1010101-taken on 2/21/13): Standing at the intersection of Bender Road and E. Badger Road, this is a view of the ditch, looking west back at the facility.

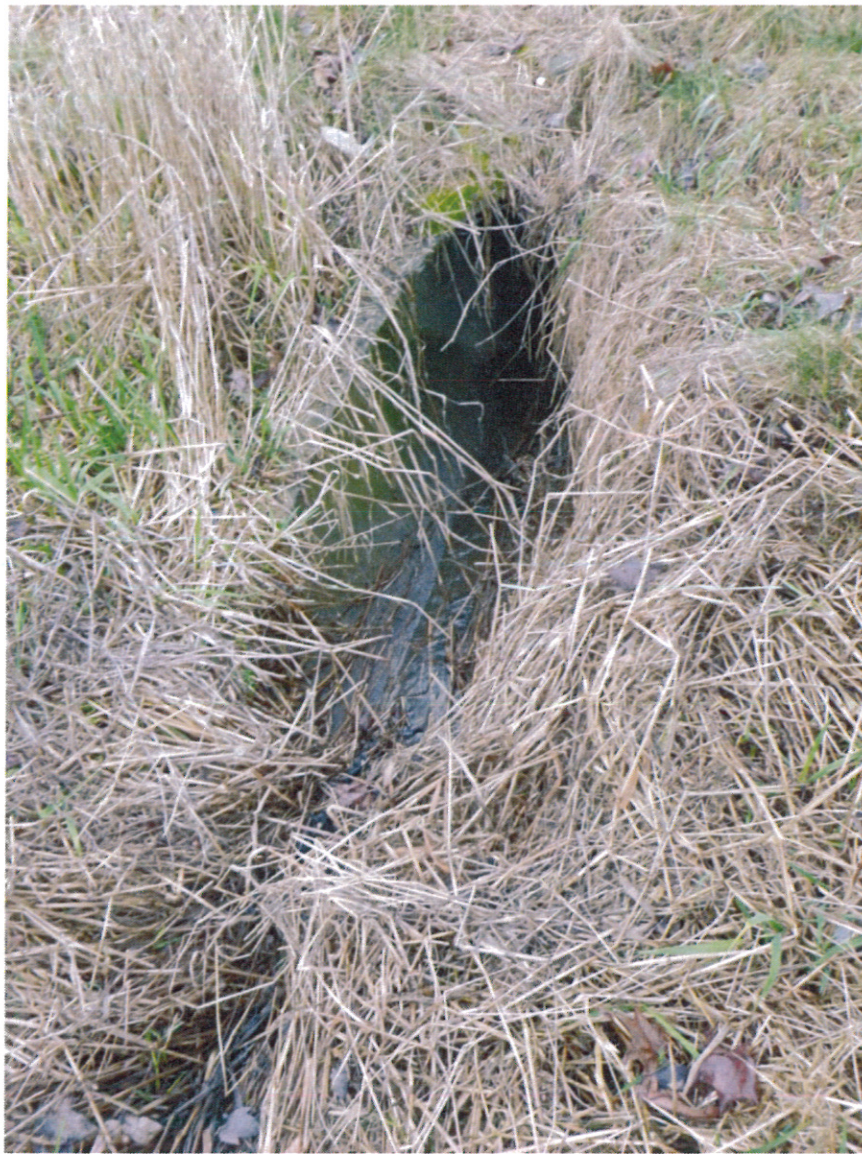
Photograph #13(P1010102-taken on 2/21/13): Facing east, this view is a continuation of the ditch from the previous photograph where it enters a culvert at the intersection of Bender Road and E. Badger Road. On February 21, 2013 there was water flowing at this point of the ditch, seen here. On February 12, 2013 water was not flowing at this point of the ditch.

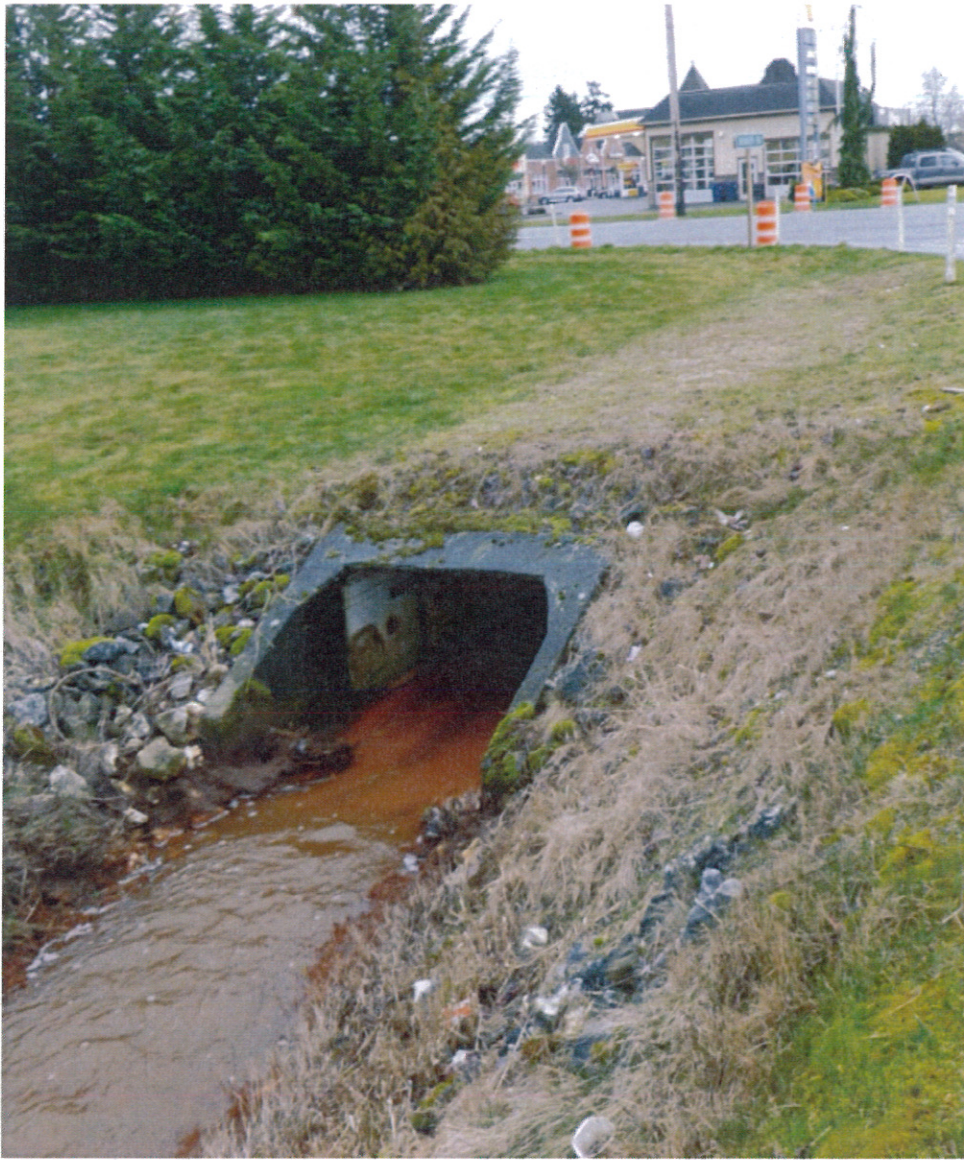
Photograph #14(P1010105-taken on 2/21/13): Looking south, this is a view of an open water conveyance that runs south along the east side of Bender Road. The ditch adjacent to the facility that runs along E. Badger Road flows toward this culvert in a perpendicular direction. In this image, flow enters a culvert north of the intersection of E. Badger Road and Bender Road. E. Badger Road appears in the background.

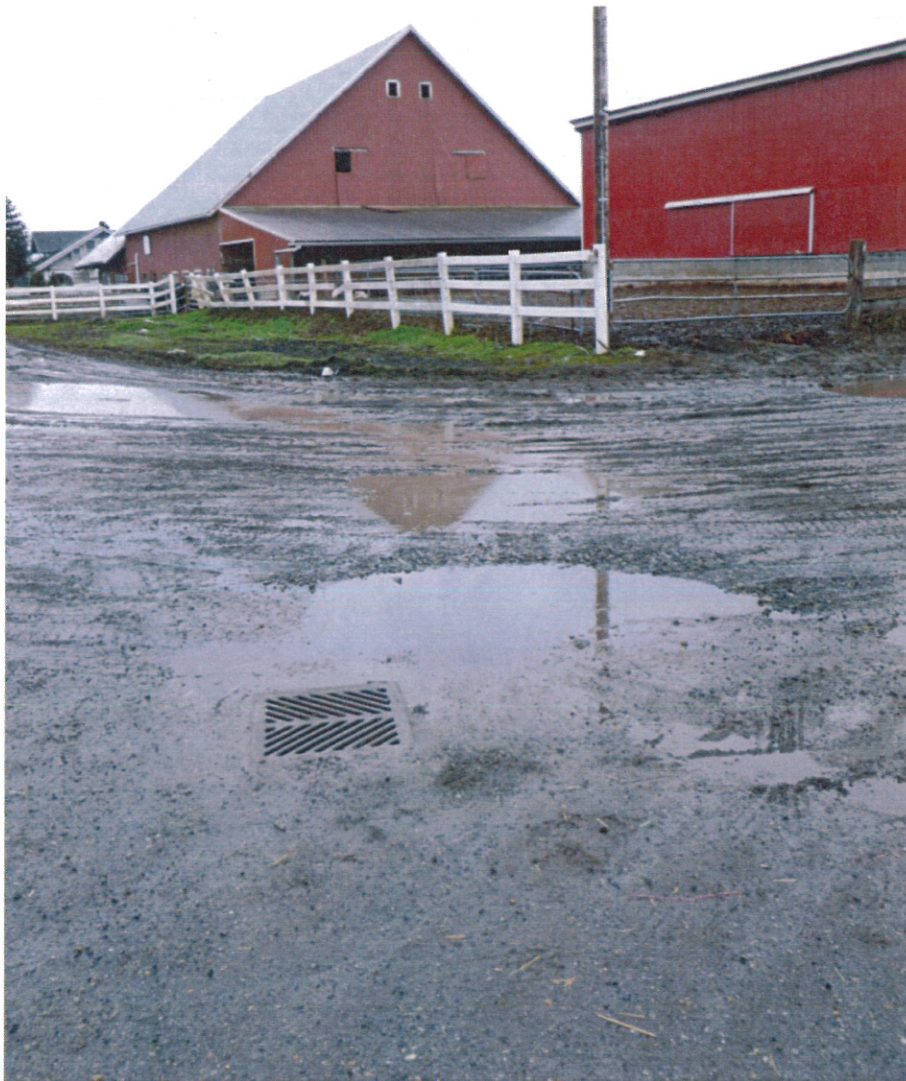
Photograph #15(P1010064-taken on 2/12/13): Looking northwest, this is a view of the dry cow confinement area and a drain. Mr. Bajema stated that this drain was installed by the city or county and routes water to the ditch.

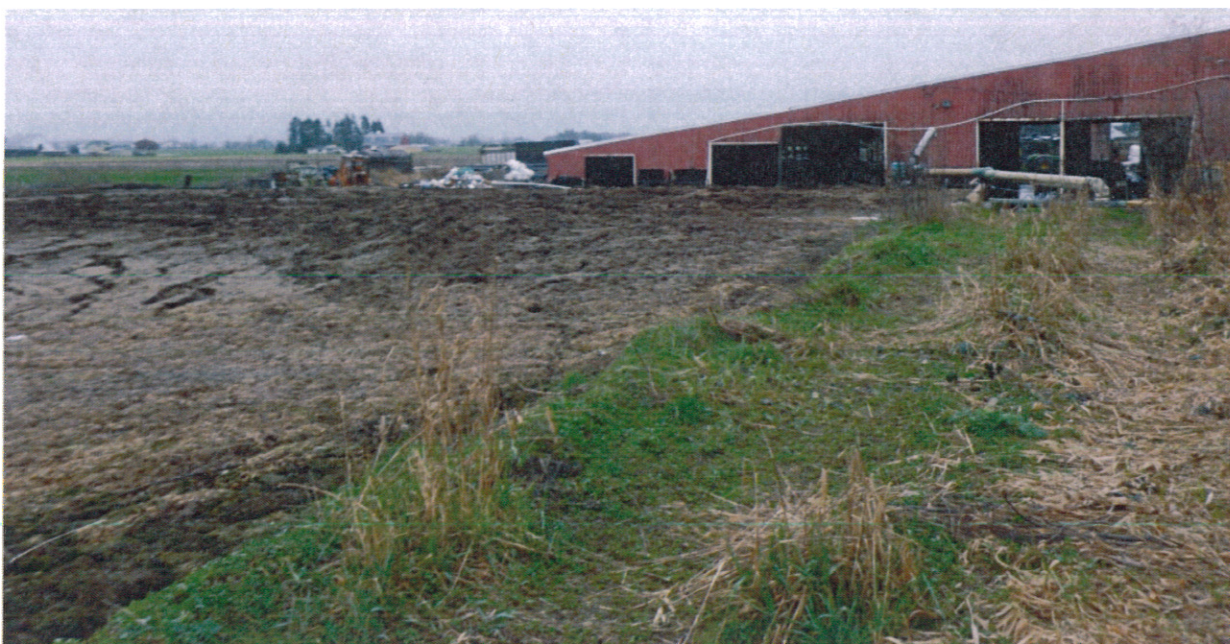
Photograph #16(P1010076-taken on 2/21/13): Looking northeast this is a partial view of the lagoon used at the facility.

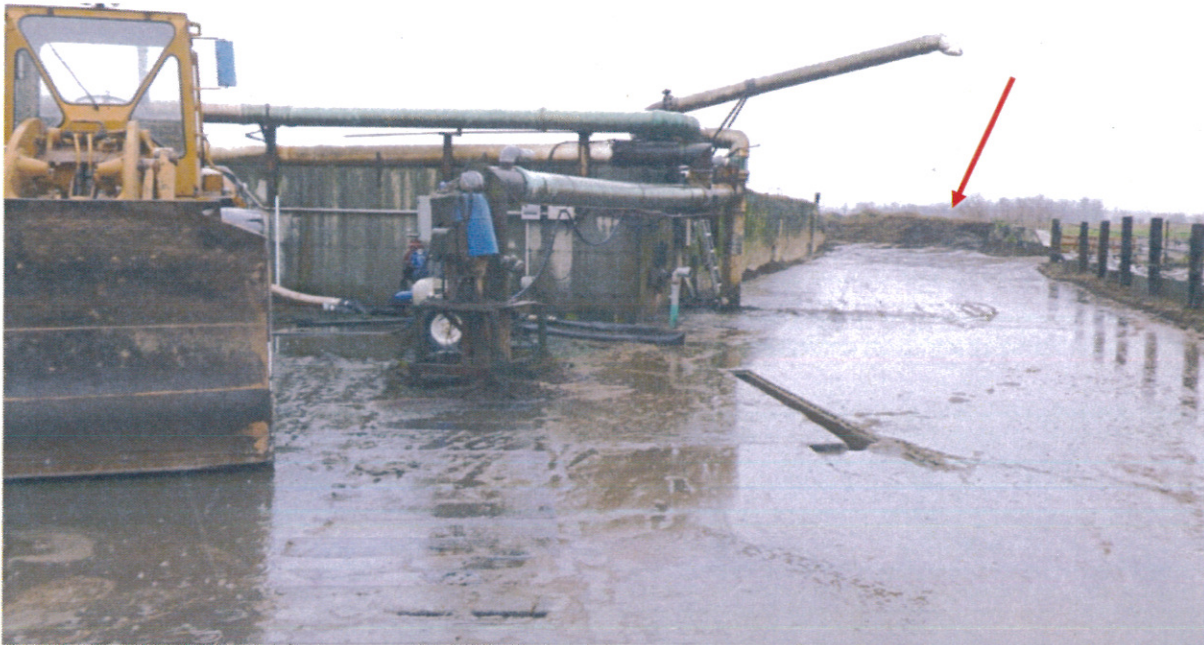
Photograph #17(P1010073-taken on 2/21/13): Looking north this is a view of the elevated lagoon on the left and one solid storage area on the right. Mr. Bajema indicated that solids will be scraped off the top of the lagoon and stored in the area, indicated by the red arrow.

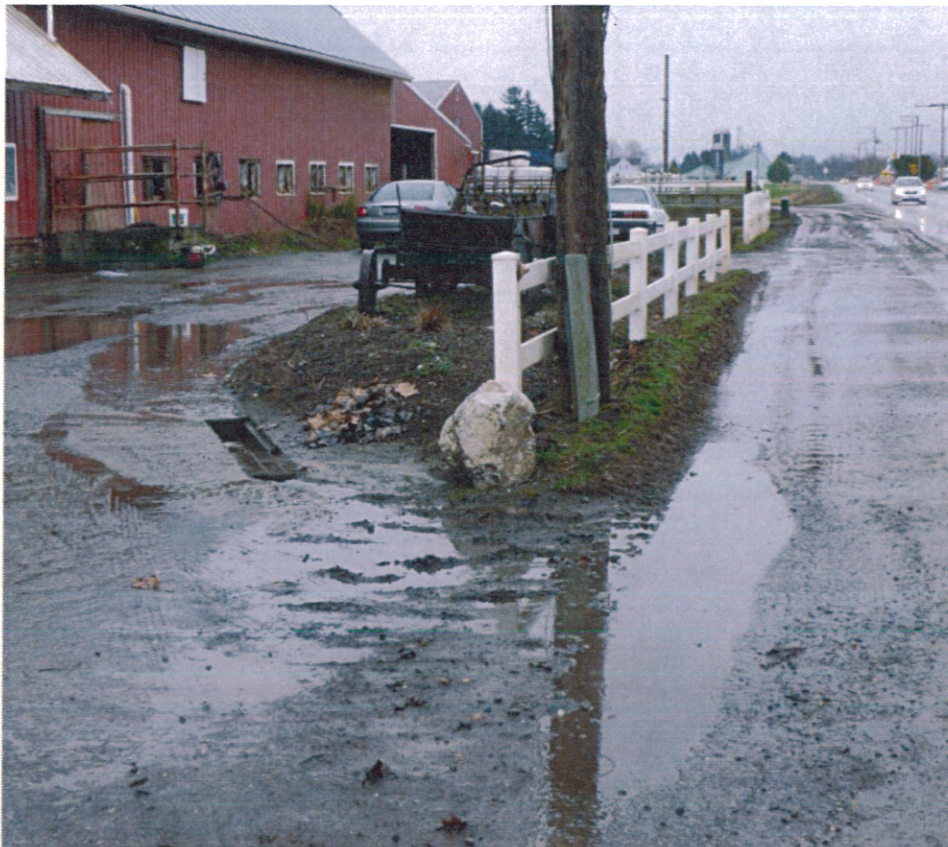
Photograph #18(P1010062-taken on 2/12/13): Looking east this is a view of a drain located on the south side of the milk house. According to Mr. Bajema, this drain routes water to the ditch and is used to drain roof runoff primarily from the milk house. A small pump, which appears in the background, is used to periodically purge a water well in this location outside the milk house. This purged well water also drains to this area. The EPA inspectors observed the pump in operation on February 12, 2013.

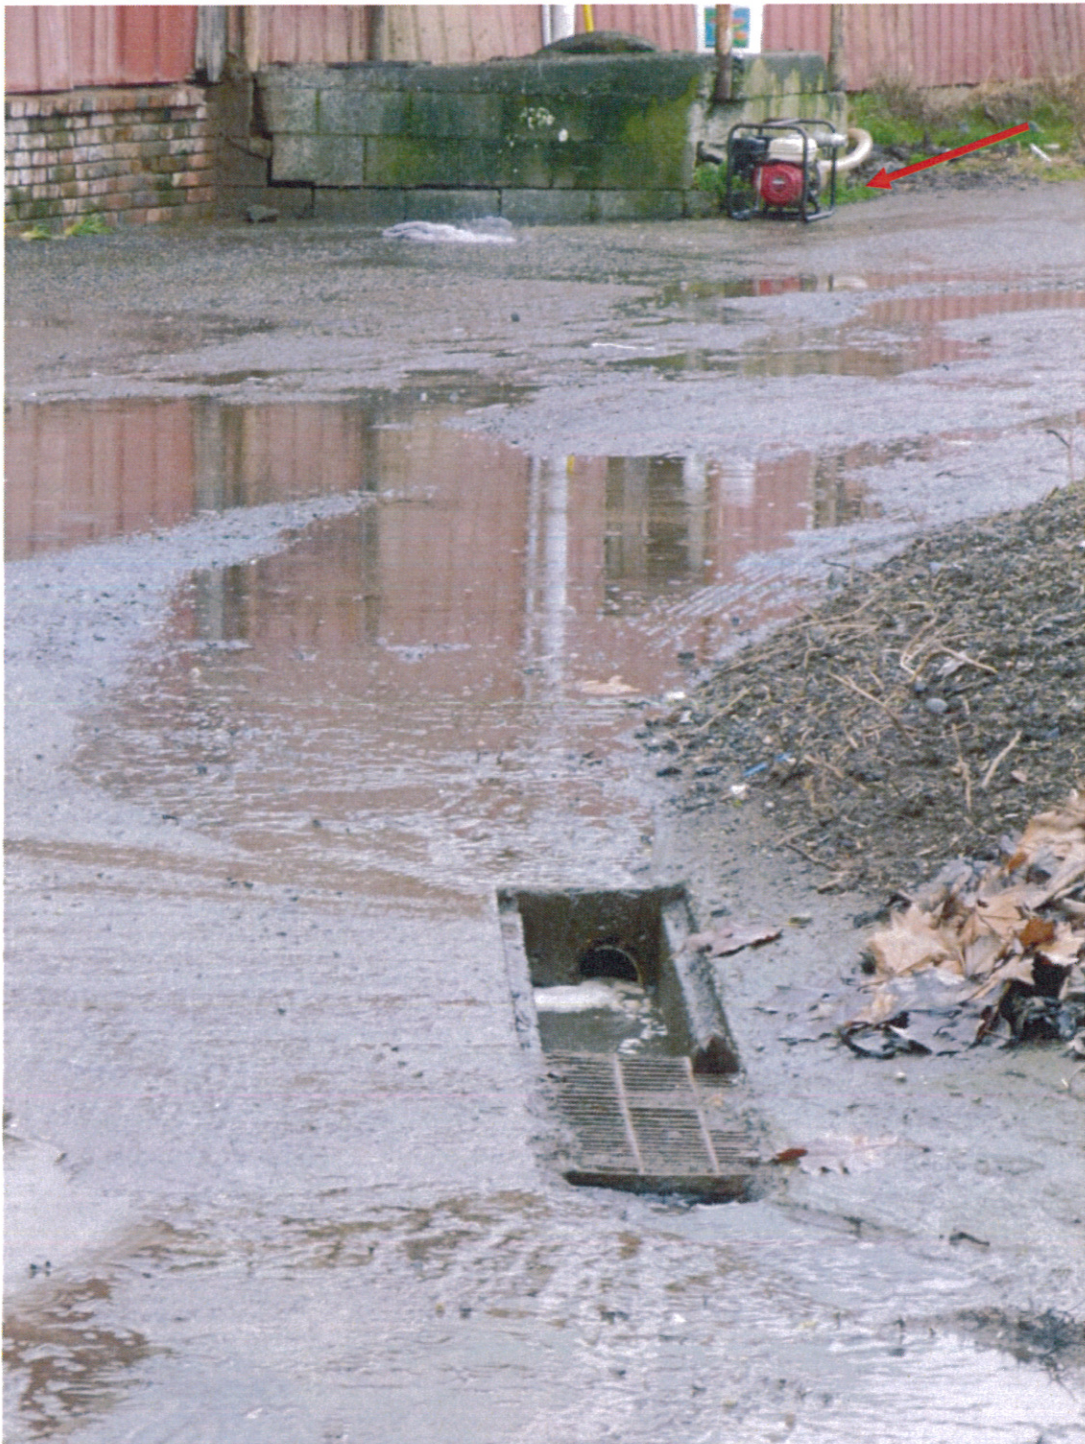
Photograph #19(P1010061-taken on 2/12/13): A close up view of the drain seen in the previous picture. The red arrow points to the pump used for well water. The well is located just behind the pump seen here.

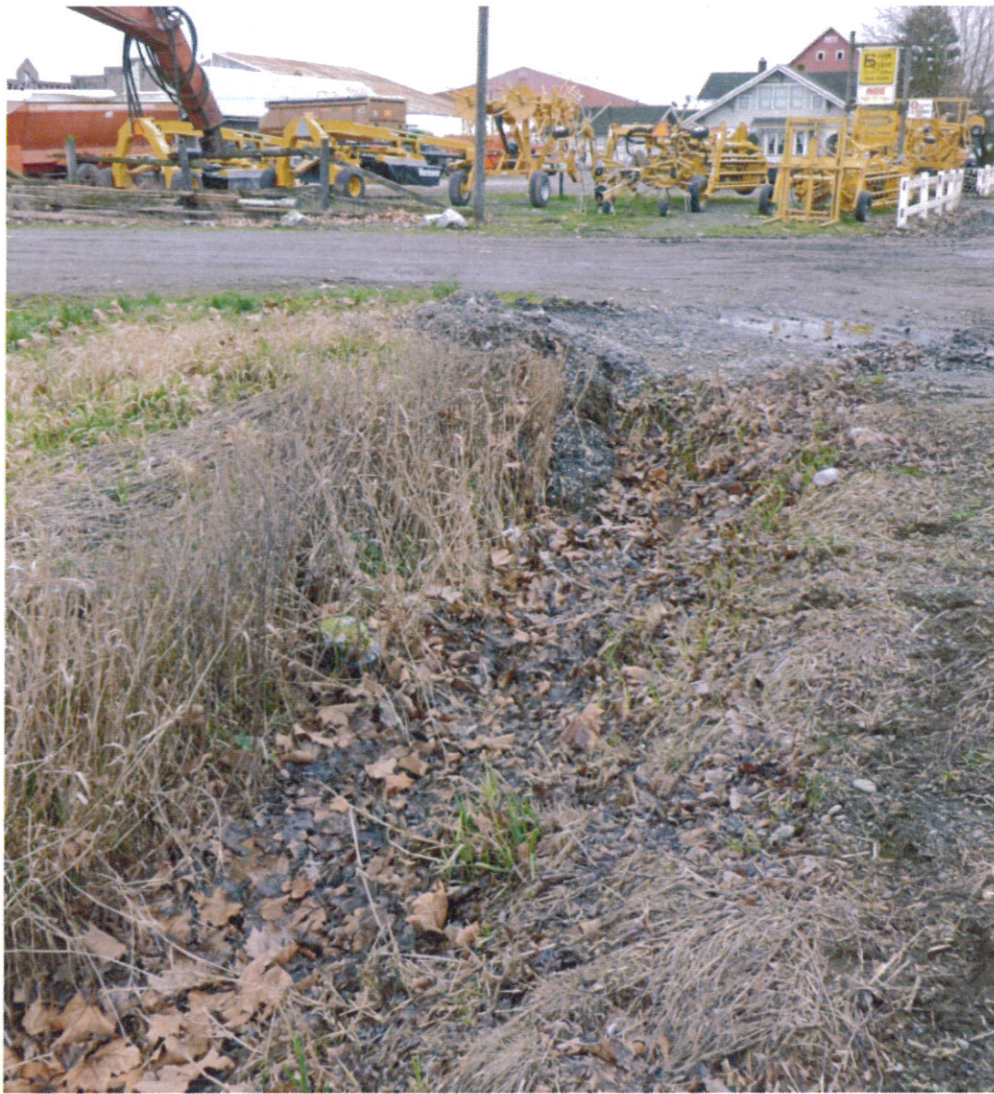
Photograph #20(P1010058-taken on 2/12/13): Looking east, this is a view of a ditch on the west side of the facility, along E. Badger Road. This ditch did not have water flowing on February 12, 2013 and February 21, 2013. There was no observable piping or a culvert that would route water in an easterly direction toward the facility or would suggest that the two ditches were connected. The facility appears in the background.

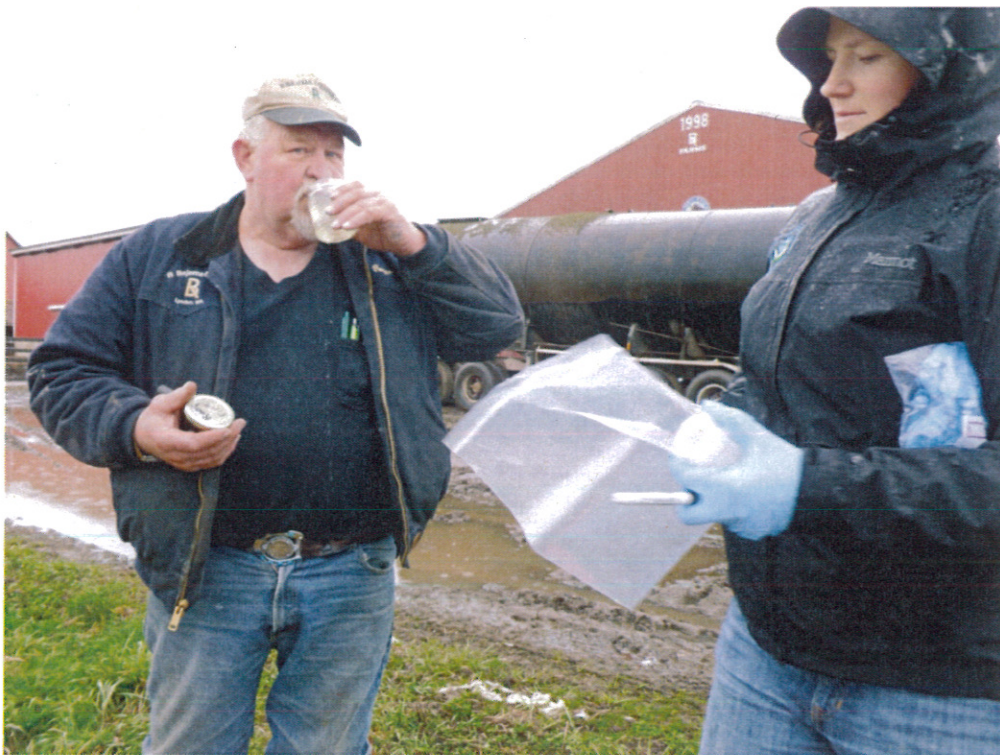
Photograph #21(P1010098-taken on 2/21/13): On February 21, 2013 the EPA inspection team collected water samples. During this time, Mr. Bajema also collected water samples. Mr. Bajema indicated that the water that EPA was collecting was good enough to drink. Mr. Bajema requested that the EPA inspectors take a photograph of him drinking from the sample he collected.
